KAWASAKI STEEL TECHNICAL REPORT

Corrosion of Steel Structured Wharves and Revetments and Their Maintenance

Kei Wada, Keisuke Shiota, Hideo Shinomiya, Yoshio Horinouchi

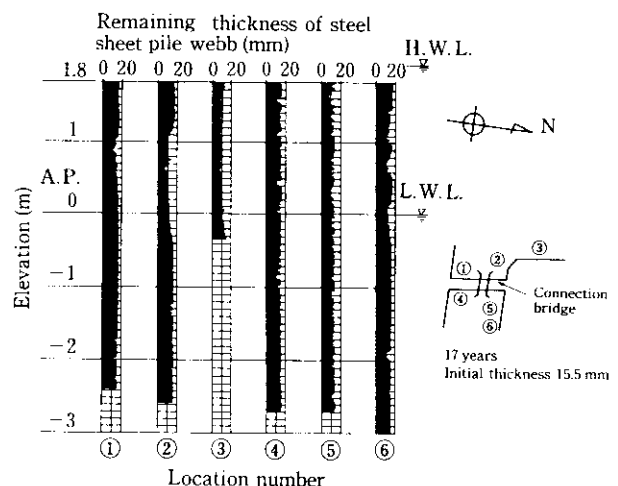
Fig. 4 Results of thickness measurement at W8 revetment

In 1987, the vertical-direction continuous plate thickness distribution was investigated at W8-quay of the West Plant, using a measuring system employing an ultrasonic thickness gauge, which can give plate thickness data at an interval of 1 cm. The result is shown in Fig. 4, the measurement areas being locations ① to ⑥ in the steel sheet pile quays on both sides of the East-West connection bridge. These points had been left unprotected for 16 years since they were constructed, and all the measurements were taken on the convex side of the steel sheet piles.

Although the patterns for plate thickness decrease are different, the corrosion between AP -400 and AP +1 800 mm (the lower end of the concrete top to the steel sheet pile) was severe. At its worst, a thickness decrease of about 12 mm was observed against the nominal thickness of 15.5 mm, leaving very little material thickness. According to previous reports,^{6,7)} conspicuous corrosion (concentrated corrosion) is liable to occur immediately below the mean low water level (H.L.W.L.), and corrosion between the low and high water levels (L.W.L. and H.W.L.) is considered to be comparatively small; but in the present investigation, it is characteristic that concentrated corrosion was identified in L.W.L.-H.W.L. The results of the thickness measurements (1985) at the West Plant and Oihama Area are shown in Fig. 5 and 6, respectively. Because W3-revetment had been given cathodic protection by an

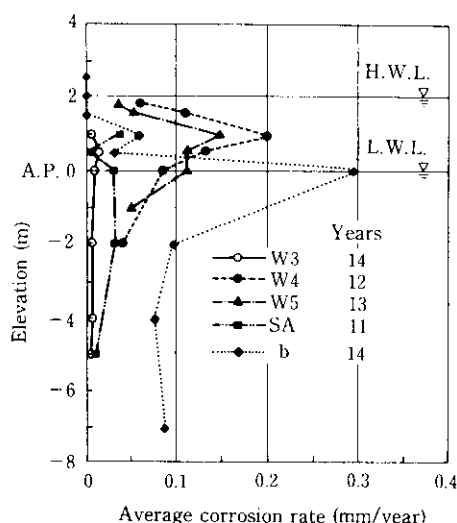
Fig. 5 Results of thickness measurement at West Plant

aluminium alloy anode since it was constructed, the mean corrosion rate was as low as 0.008 mm/year. Different corrosion rates were observed at places such as the non-corrosion-protected W4 and W5 revetments, East-West connection bridge (point b) and SA-berth. The maximum value of the corrosion rate was found at a location between L.W.L. and M.S.L., its value being within the range of 0.04 to 0.3 mm/year. In the seawater-immersed portion of AP -2.0 m or below, the corrosion rate was below 0.1 mm/year. In the previous investigations,^{6,7)} it was reported that the mean corrosion rate on the convex surface of steel sheet piling was 0.057 mm/year near M.S.L., 0.126 mm/year near L.W.L. and 0.068 mm/year in the upper zone immersed in seawater. In the case of the W4 and W5 revetments, the same corrosion rates as those in the previous investigations were obtained in the vicinity of L.W.L. and in the upper immersed zone, but near M.S.L., the corrosion rate was 1.6 times greater, thereby indicating that concentrated corrosion had occurred. In the steel pipe pile at point b, on the other hand, the peak value was seen at L.W.L., and the corrosion rate below L.W.L. was larger than that in the steel sheet pile, thereby giving a corrosion rate profile approximating to the value from the previous investigations. With the steel pipe pile at SA berth, no concentrated corrosion near the tidal zone was observed. The corrosion rates for non-corrosion-protected steel materials in "Technical Standard for Harbor Facilities and Commentaries⁸⁾" are 0.3 mm/year in the splash zone above H.W.L., 0.1 to 0.3 mm/year in the tidal zone from H.W.L. to L.W.L., 0.1 mm/year in the seawater zone between L.W.L. and the sea bed, and 0.03 mm/year in the soil zone of the sea bed. These values near the maximum values of the mean corrosion rate in the non-corrosion protected areas shown in Fig. 5.

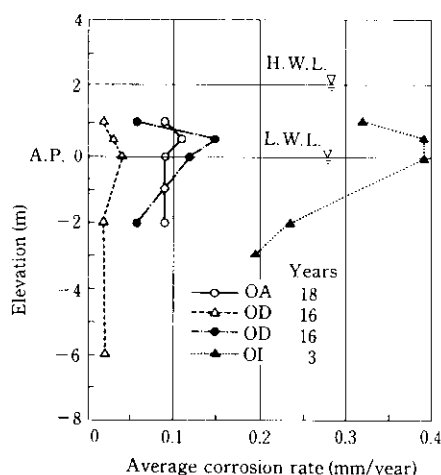
Fig. 6 Results of thickness measurement at Oihama area

Regarding Fig. 6, OD-berth was given cathodic protection from the time of its construction; hence, its corrosion rate was nearly constant in the depth direction, being as low as 0.05 mm/year or less. Although OA-berth was given cathodic protection from the time of its construction, like OD-berth, its corrosion rate was higher at 0.09 mm/year. This may have been caused by the fact that the cathodic protection method by the impressed current system, which was installed at the time of its construction, was not of order for some time, thereby leaving OD-berth without corrosion protection. On the other hand, the interlocked steel pipe pile wall of OD-berth and OI-berth, which had no corrosion protection, were severely corroded in the tidal zone and showed the same trend as that at the West Plant. The corrosion rate at OI-berth was as high as 0.39 mm/year at the peak value, this steel sheet pile having a special construction with both sides exposed to seawater so that corrosion from both sides was progressing. If the corrosion rate from both sides was converted into a single-side corrosion rate, the corrosion rate in the tidal zone would be about 0.2 mm/year.

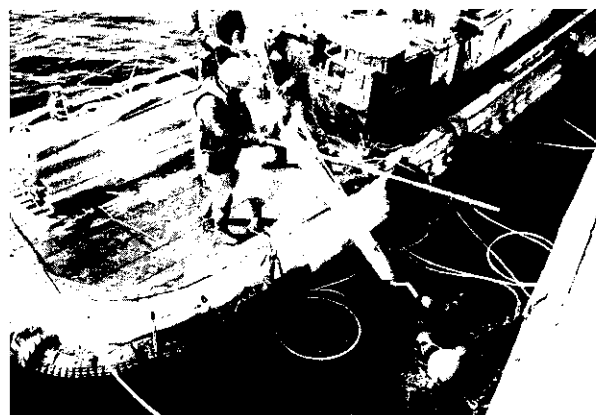
Cathodic protection at present uses the aluminium alloy anode system in all cases, and a typical installation is shown in **Photo 2**. In terms of design, the life of the anode is set at 10 years. Regarding the protective current density at the start of cathodic protection, the design was based on the result of a preliminary electric current flow test at O-berth of 130 mA/m² in seawater, 30 mA/m² in the sea-bed soil and 60 mA/m² in the rubble mud. In calculating the design life of the anode, it is considered that the required corrosion-prevention current after the design life has elapsed will have dropped to about half the initial value. The electrode potential for cathodic protection is set at -800 mV vs. SCE. The consumption rate of the anode is liable to be different from the design consumption rate due to changes in the water quality and water depth. Thus, electrode potential monitoring is carried out once a year in order to confirm whether or not the potential of the anode after its installation is being kept at a lower potential than the electrical potential for cathodic protection. At any position where the anode potential was higher than the electrode potential for cathodic protection and where the elapsed years of the anode were approaching the design life, a diver was employed to

Photo 2 Aluminum alloy anode installation

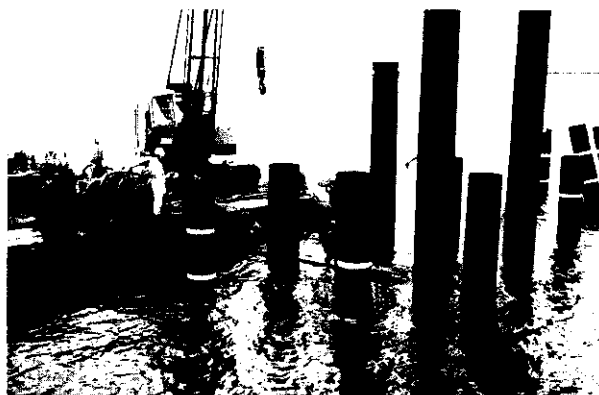
Photo 4 KPP pile installation for the renewal of E-berth

At E-berth, the corroded steel pipe piles were repaired by fitting a heavy-duty, anti-corrosion steel pipe pile (KPP pile) over the corroded steel pipe pile (the former being of a larger size than the latter), and by grouting the gap between the two pipe piles with concrete.
