KAWASAKI STEEL TECHNICAL REPORT

No.43 (October 2000)

Corrosion Behavior of Vehicles Operated in North America for 5 Years

Morishige Uchida, Kazuo Mochizuki

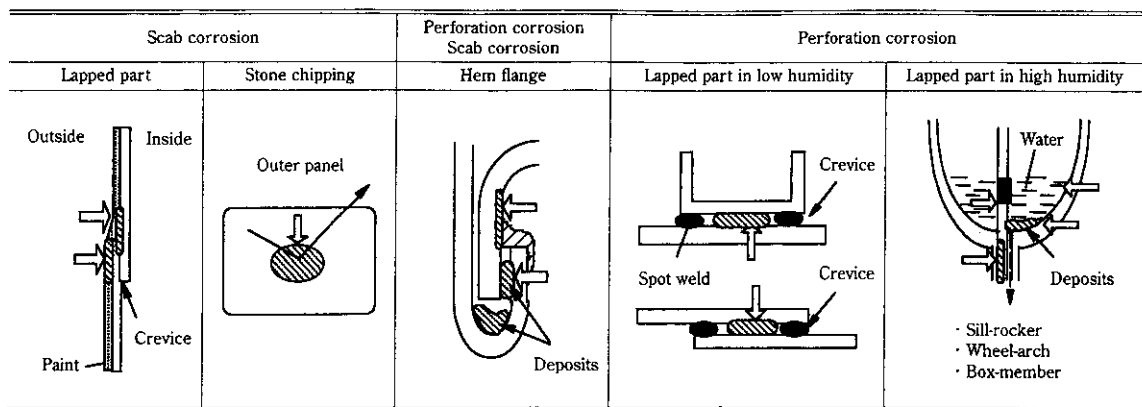
The behavior of cosmetic corrosion and perforation corrosion in motor vehicles was classified for evaluation according to the corrosive environment (degree of wetness/dampness) and design shown in Fig. 1. Portions of cosmetic corrosion were classified into lapped part, outer panel (chipping corrosion), and hem flange. Portions of perforation corrosion were divided into hem flange (in which corrosion is generally considered to be severe), a lapped part with a box structure in which humidity is high because of stagnant water (side sill, member and rear wheel), and other lapped parts.

Fig. 1 Schematic design of corrosion of specific area of parts classified into a design and humid condition

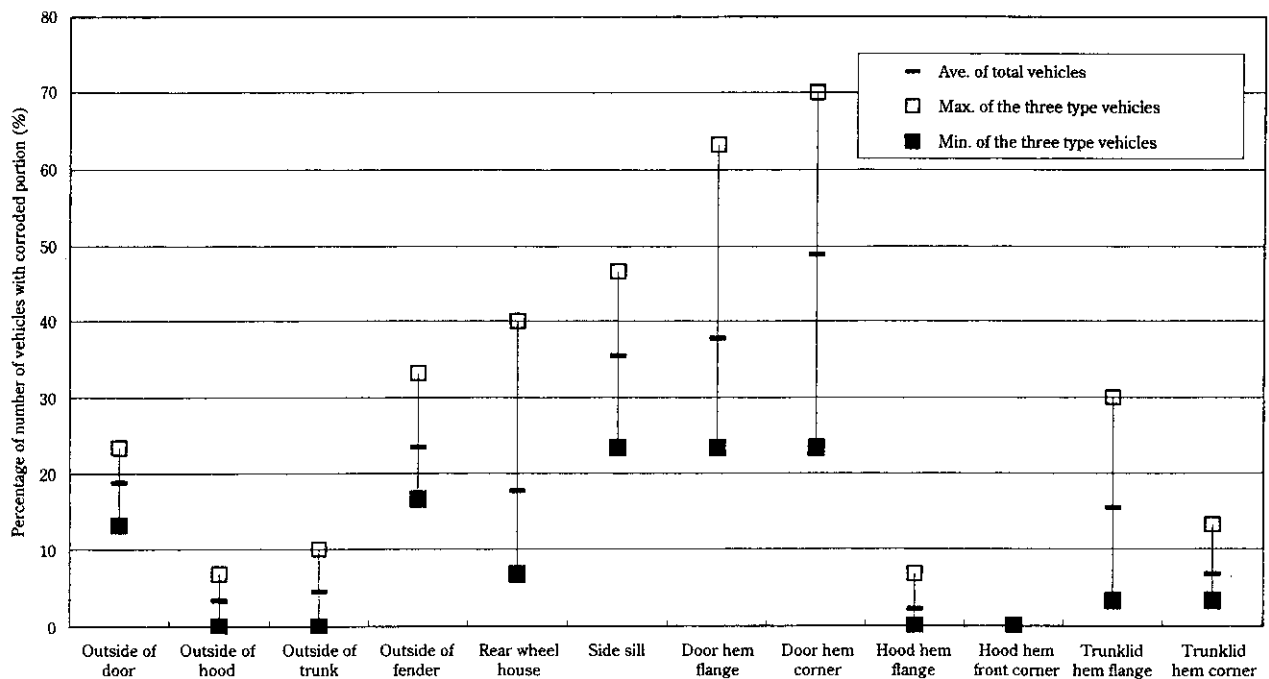
The percentage of three types of 1989 model cars with corroded portions in each body part by visual inspection is shown in Fig. 2. Here, there were 90 vehicles in all, i.e., 30 of each type.

Among all of the vehicles (90 vehicles), the corroded portions observed in the largest number of vehicles were door hem lower corners (49%), door hem flanges (38%) and side sills (bottom rails) (36%). These portions showed a great difference in the percentage of vehicles with corroded portions, which depends on the vehicle

Fig. 2 Comparison of survey results at each of body part

type, from other portions. The difference in design and corrosion protection systems probably affected this corrosion behavior.

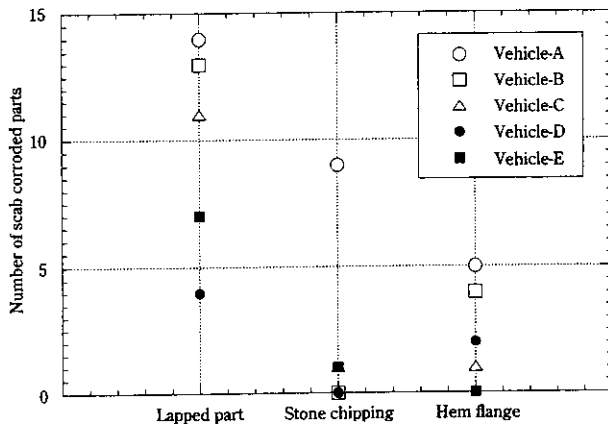
The number of scab-corroded parts in each body part before the dismantling is shown in Table 3. The number of scab-corroded parts classified by the corrosive environment is shown in Fig. 3. As is apparent from Fig. 3, scab corrosion was observed most frequently in lapped parts. This corrosion was under film corrosion initiated in lapped parts. Damage by chipping was observed in hoods, doors, fenders, etc. Scab corrosion

Fig. 3 Scab corrosion at each of the part

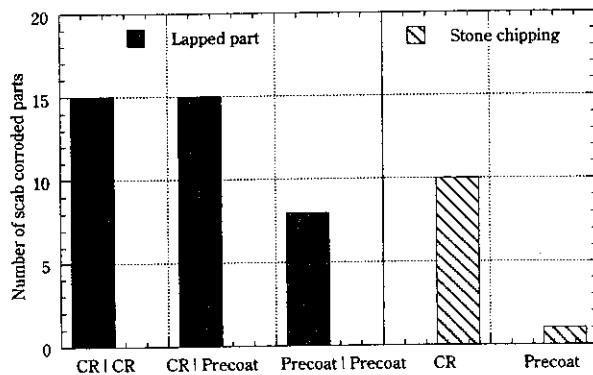
The data shown in Fig. 3 were rearranged with respect to the effect of combinations of types of steel sheets on the occurrence of scab corrosion and the effect of zinc coating on the occurrence of scab corrosion in chipped portions (Fig. 4). Although cold-rolled steel sheets alone and the combination of a non-precoated surface (including a one-side precoated steel sheet) and a zinc-coated surface showed the same number of scab-corroded parts, this number decreased to about half for zinc-coated steel sheets alone. In other words, in the corrosive environment of lapped parts of exterior panels, the anticorrosion performance of zinc-coated steel sheets could not manifest itself sufficiently when a non-precoated surface was

Fig. 4 Effect of zinc coating on anti-scab corrosion

present, whereas two-sided zinc coating showed excellent performance in cosmetic corrosion. Zinc coating had a great effect on the scab corrosion in chipping portions and the number of scab-corroded parts of a zinc-coated surface was 1/10 that of a non-precoated surface. In other words, two-sided zinc coating was effective in preventing the occurrence of scab corrosion in body panels.

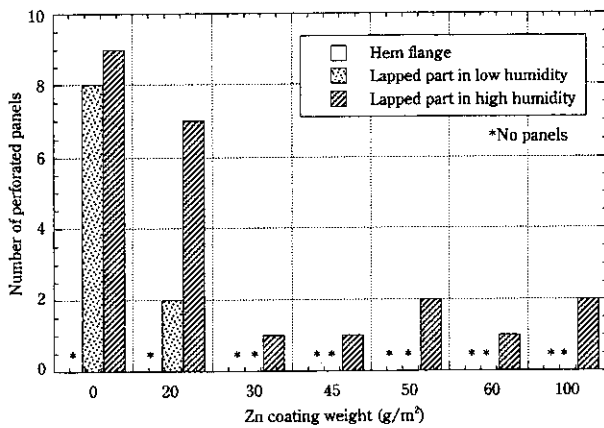
The number of perforated panels as a function of zinc coating weight is shown in Fig. 5. In lapped parts without a box structure, perforation corrosion occurred in cold-rolled steel sheets and zinc-coated steel sheets with coating weight of less than 20 g/m², whereas perforation corrosion was not observed in zinc-coated steel sheets with coating weight of at least 30 g/m². Even in very damp box members, the number of perforated panels showed a tendency to decrease with increasing zinc coating weight. However, some perforation corrosion was observed even in zinc-coated steel sheets with coating weight of more than 30 g/m².

Fig. 5 Effect of zinc coating weight on anti-perforation corrosion

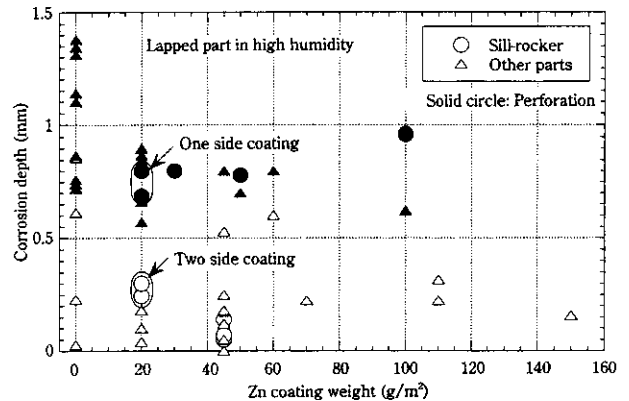
Figure 7 shows the relationship between zinc coating weight and corrosion depth in lapped parts with a box structure in a high dampness condition. In contrast to lapped parts without a box structure, there was no clear tendency for corrosion depth to decrease with increasing zinc coating weight. In box members, perforation corrosion was observed even in zinc-coated steel sheets with a coating weight of 100 g/m². When the condition of heavily perforated corrosion was investigated, mud was observed in the corroded portions.

Fig. 7 Relation between Zn coating weight and corrosion depth at the lapped part in high humidity of field vehicles for 5 years

As shown in Fig. 7, even in some two-side coated steel sheets with zinc coating weight of 20 g/m², perforation corrosion did not occur in a box member (lapped part between a sill and a rocker). Mud was not observed in the body panels, thus the lapped part with a box structure was not in a damp condition for a long time, in contrast to the body panels in which perforation corrosion occurred.

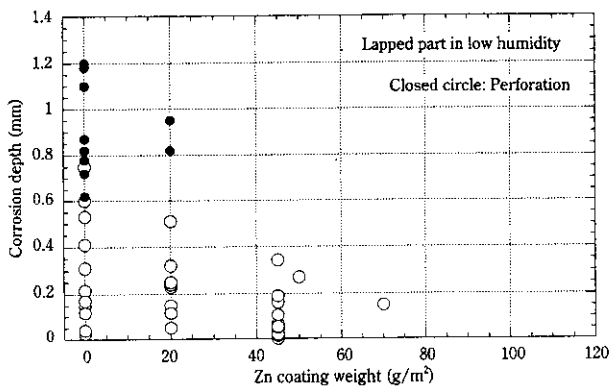
Figure 6 shows the relationship between corrosion depth and zinc coating weight in lapped parts without a box structure. It is apparent that corrosion depth decreases with increasing zinc coating weight. In lapped portions without a box structure in a low dampness condition, the effect of zinc coating weight can be observed, and zinc-coated steel sheets with coating weight of at least 45 g/m² show excellent anticorrosion performance.

Fig. 6 Relation between Zn coating weight and corrosion depth at the lapped part in low humidity of field vehicles for 5 years

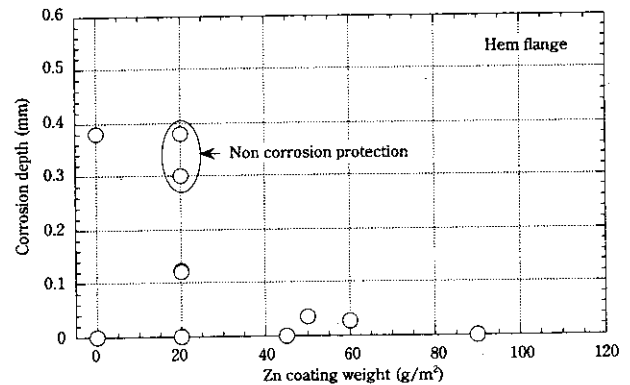
The relationship between corrosion depth in hem flanges and zinc coating weight is shown in Fig. 8. In zinc-coated steel sheets with zinc coating weight of 20 g/m², the corrosion depth in body panels with corrosion protection systems decreased. Further, a decrease in corrosion depth due to an increase in zinc coating weight was observed. The corrosion depth of cold-rolled steel sheets was about 0.4 mm, whereas that of coated steel sheets with zinc coating weight of more than 45 g/m²

Fig. 8 Relation between Zn coating weight and corrosion depth at the hem flange of field vehicles for 5 years

was less than 0.1 mm.

It can be said that the use of zinc-coated steel sheets also has a great effect on the perforation corrosion of hem flanges. Excellent anticorrosion performance can be obtained by the combined use of zinc-coated steel sheets with coating weight of more than 45 g/m^2 and corrosion protection systems.

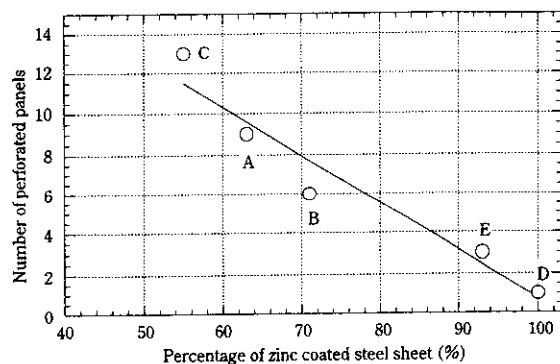
Fig. 9 Correlation between percentage of zinc coated sheet forming the vehicle body shell and number of perforated panels

Figure 9 shows the relationship between the percentage of zinc-coated steel sheets forming the vehicle body shell and the number of perforated panels. The number of perforated panels decreased with increasing percentage of zinc-coated steel sheets forming the vehicle body shell. It is clear that the anticorrosion performance of body panels was improved by the use of zinc-coated steel sheets. Such use also contributed greatly to the improvement of the anticorrosion performance of body panels although other corrosion protection measures (design, additional corrosion protection, improvement of paint systems) have also been effective.
