Large-scale Shoring Work in Existing Building

NKK successfully constructed surface treatment lines, including an electrolytic tinning & tin free (chromium plating) line, at the Erdemir Iron & Steel Works on the coast of the Black Sea in Turkey. One of the most difficult components of this project was the large-scale shoring work in an existing building, which was performed under various restrictions including the choice of construction method, limited construction materials and restricted construction space on site. Shoring was necessary to excavate a half of the building area (1950 m²) and construct two concrete pits (10 m deep). As a result, the shoring work was safely completed, and the efficiency of the work plan was demonstrated. Problems during construction, along with the associated countermeasures and their effects on this large-scale shoring plan are introduced.

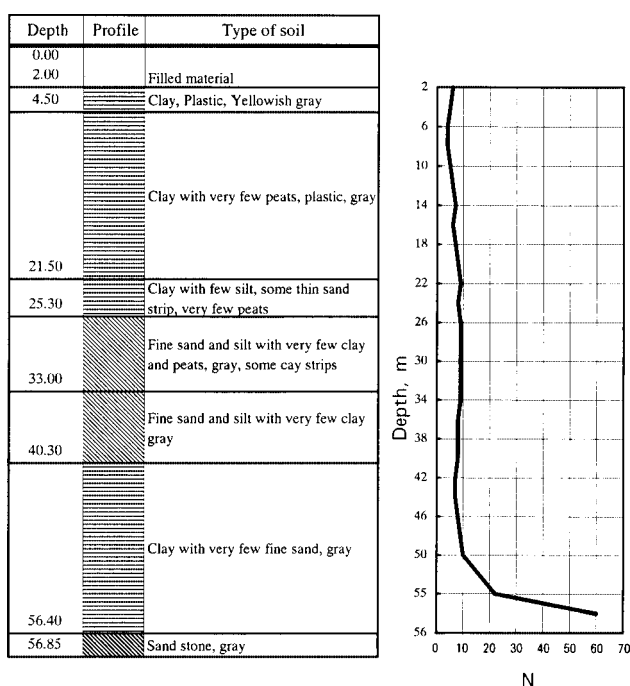
Fig. 5 Soil profile

As shown in **Fig. 5**, the soil on the construction site consists of homogeneous clay with a cohesion strength of $C=40\text{--}70\text{ kN/m}^2$. Bedrock for the piles lies underground at -55 m , and the groundwater level is -2 m below ground.

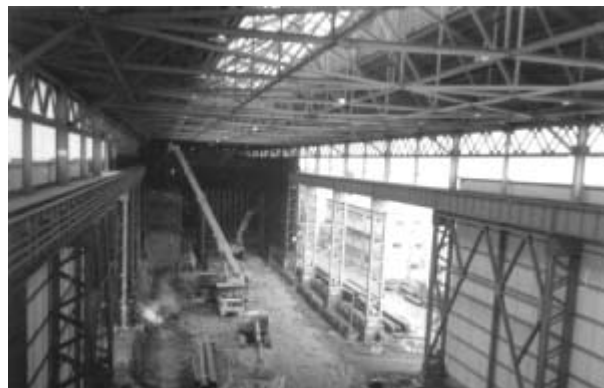
Photo 1 Steel pile driving

The steel sheet piles were driven with a 60 kW vibro-hammer since this would not adversely affect any nearby equipment. **Photo 1** shows the progress of sheet pile driving.

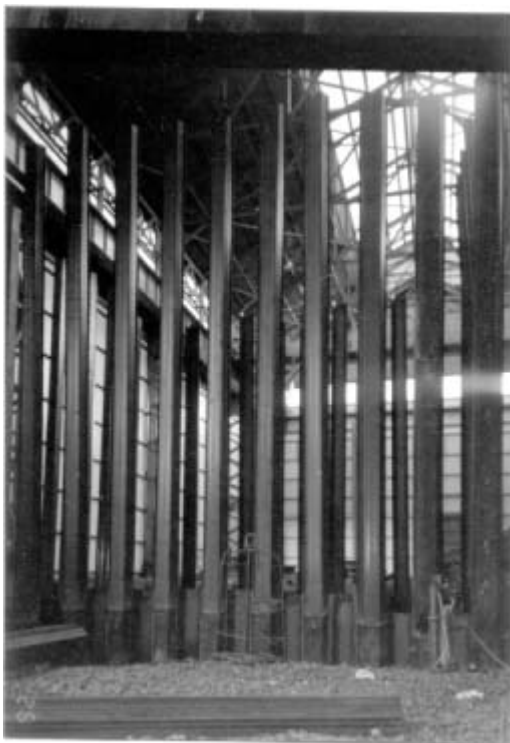
Photo 2 Steel pile jointing

Because of the height restriction in the existing building, 20 m long steel sheet piles were cut into two parts, and combined sheet piles consisting of an 8 m long pile and 12 m pile were driven. In this case, the operating time loss of heavy machines such as the vibro-hammer occurs if driving of the steel sheet pile is not started until after welding of the adjacent combined sheet pile is completed, resulting in a decrease in work efficiency. For this reason, and considering the fact that welding can be performed continuously because the interior of the existing building protected from winds, the welding and driving operations were separated. The lower steel sheet piles were driven first, and then every other upper steel sheet piles was welded, as shown in **Photo 2**. After driving the comb-like upper combined sheet piles, the remaining upper steel sheet piles were similarly welded into a comb shape and then driven.

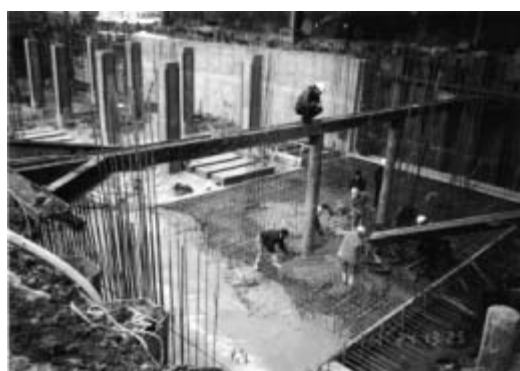
Photo 3 Temporary beam

The measurements taken for the first block suggested that the existing building foundations could shift in other blocks as well. A local support beam was installed as shown in Photo 3 before the start of evacuation, and work was carried out by using the local sup-
