Extended Life of Boiler by Inconel Cladding

The boiler is a facility that recovers waste heat of CO gas generated in the converter furnace and is installed in the upper part of the converter furnace. The converter furnace processes molten iron in batches per ladle. Therefore, the passage of exhaust gas and temperature rise/fall are also repeated in batches. For this reason, the deterioration of the boiler was mainly by wear due to dust and cracks due to thermal stress. However, since low-grade scrap was charged in the converter to reduce the mixing ratio of hot metal after 2006, wall thinning of tube due to corrosion became noticeable. Under this situation, as a countermeasure against corrosion, Inconel, which is a Ni-based alloy, is welded on the surface of boiler tubes. As a result, the life span of the boiler was extended from 5 to 10 years.

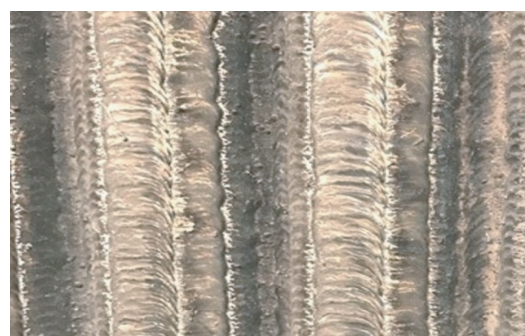
Fig. 9 Properties of surface after cladding

The actual equipment test revealed that stress concentrates in the bead overlap area, and this shortens cracking life. Therefore, flat plate specimens with two types of Inconel alloy cladding having different surface qualities were prepared, and a thermal shock test was conducted¹⁾. The results showed that life extension is possible by performing conditioning to smooth the surface. Based on this, when the Inconel alloy was introduced in the actual equipment, smoothing was performed with a grinder after cladding with the Inconel alloy. **Figure 9** shows the surface quality after cladding but before smoothing, and **Fig. 10** shows the surface quality after smoothing.

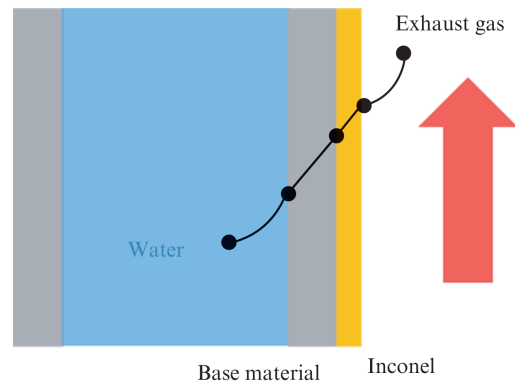
Fig. 13 Schematic diagram of heat conduction

To realize a further extension of boiler life in the future, it will be necessary to extend cracking life. Because cracking life varies depending on the thickness of the Inconel alloy, the generated stress was calculated with different thicknesses. First, the temperature distribution was calculated assuming the 1D steady heat transfer shown in Fig. 13. The following equation was used in these calculations.

$$h_g(T_g - T_i) = \frac{k_i}{L_i}(T_i - T_b) = \frac{k_s}{L_s}(T_b - T_s) = h_w(T_s - T_w) \quad (4)$$

where, h_g : heat transfer coefficient of flue gas (W/m²K), T_g : temperature of flue gas (°C), T_i : temperature of Inconel alloy (°C), k_i : heat conduction rate of Inconel alloy (W/mK), L_i : thickness of Inconel alloy (mm), T_b : temperature of boundary surface (°C), k_s : heat conduction rate of base metal (W/mK), L_s : thickness of base metal (mm), T_s : temperature on water-cooling side of base metal (°C), h_w : heat transfer coefficient of boiler water (W/m²K), T_w : temperature of boiler water (°C)
