KAWASAKI STEEL TECHNICAL REPORT

Corrosion of Steel Structured Wharves and Revetments and Their Maintenance

Kei Wada, Keisuke Shiota, Hideo Shinomiya, Yoshio Horinouchi

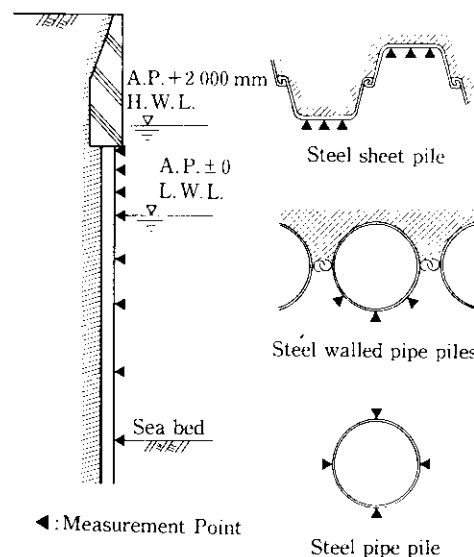
Fig. 3 Measurement point of steel plate thickness

structures at the West Plant and over the entire Oihama Area. Measurement areas were set at an interval of about 50 m along the revetments and quays, the locations of the measuring points for plate thickness being shown in Fig. 3. The points to be measured were set at an interval of 0.5 m in the zone from H.W.L. to L.W.L., and at an interval of 1.0 m in the zone from L.W.L. to L.W.L.-2.0 m, thereby giving 5 to 9 points in total in each area. To measure plate thickness, three points were taken respectively on the convex and concave surfaces

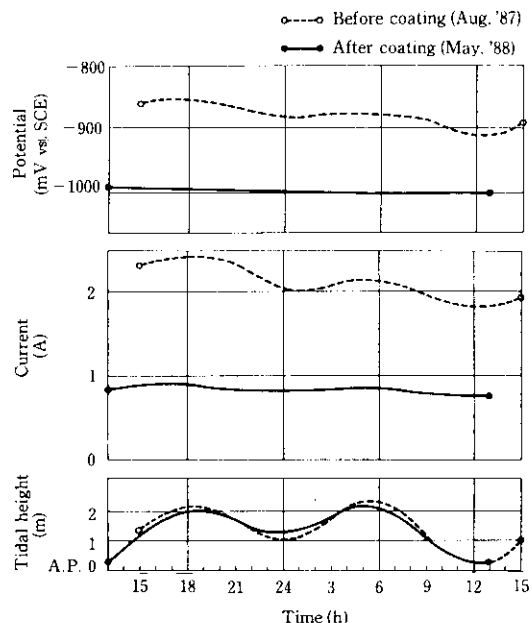
Fig. 7 Change of potential and current in a day

Daily variations in the potential and the protective current were compared before and after coating, the result being shown in Fig. 7. Before the coating was applied, the potential and protective current for the steel sheet piles changed, but after coating no changes in the

potential and current were apparent. Compared with before coating, the potential was reduced by about 110 mV, and the protective current decreased by about 1.2 A (about 57%).

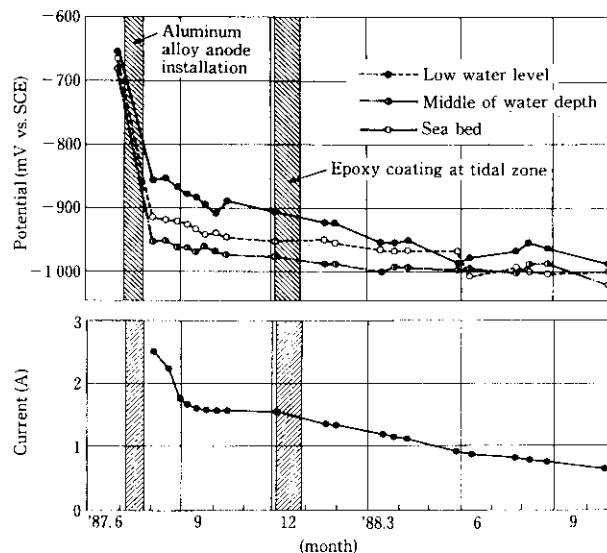
Fig. 8 Change in potential and current with time

Changes in the potential and current with time are shown in Fig. 8. After the coating work in December 1987, the potential began to drop and the protective current also decreased, thereby demonstrating the effect of coating in the tidal zone.

decreased and longer life of the aluminium alloy anode could be expected. It is considered that the protective current would increase depending upon the degree of deterioration of the coating. Conversely, it was possible to diagnose the soundness of the coating by measuring the potential and protective current.

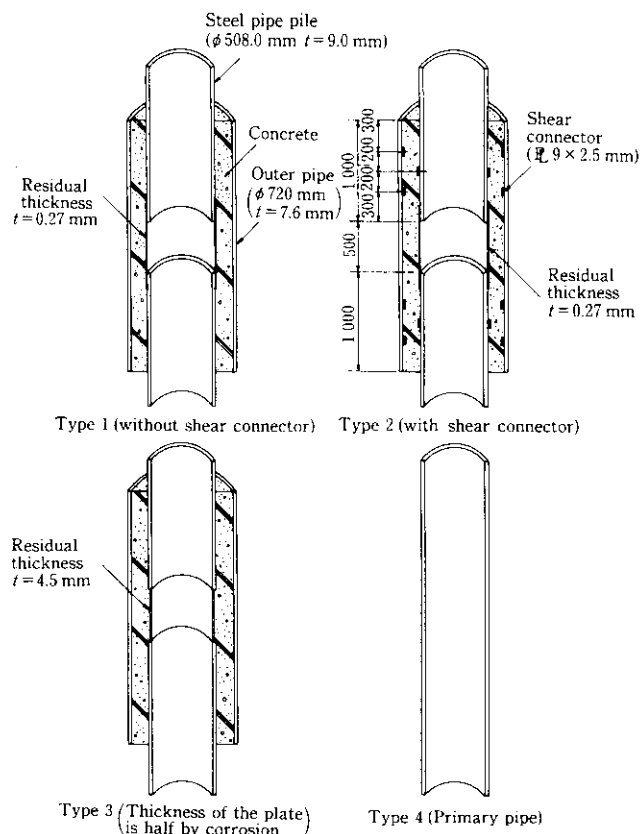
Fig. 9 Specimens for loading tests

The structure types which were compared are shown in Fig. 9. Bending tests and compression tests were conducted on all four types. Type 1, whose corroded por-

tion had no cross section at all, was reinforced against bending by the external pipe. With type 2, whose corrosion resulted in the loss of cross section like type 1, reinforcement against bending was provided by the outer pipe, and the axial force was handled by reinforcement with ribs. With type 3, whose corroded area was reduced to half the original thickness, bending and axial forces were handled by external-pipe reinforcement and the residual plate thickness together. Type 4 was a sound pipe. For the corroded steel pipe model, steel pipe with an external diameter of 508.0 mm and thickness of 9.0 mm was used. For the reinforcing pipe model, steel pipe with an external diameter of 720.0 mm and a thickness of 7.6 mm was used.

When the steel pipe piles for the piers of the East-West connection bridge were repaired by the double-pipe method, a full-scale model test was carried out prior to the site work in order to confirm the reinforcing effect.

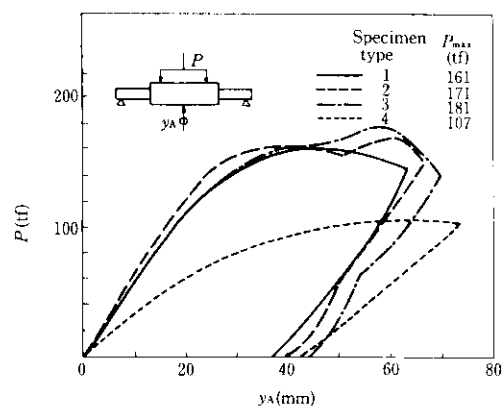
Fig. 10 Load (P)—displacement at the centre (y_A) in the bend test

The relationship between the load and central displacement of the specimen in the bending tests is shown in Fig. 10. In the case of types 1, 2, and 3, whose corroded areas had been reinforced, displacement from the same load as that applied to type 4 was little, and the reinforcing effect on bending rigidity by the external pipe was demonstrated.

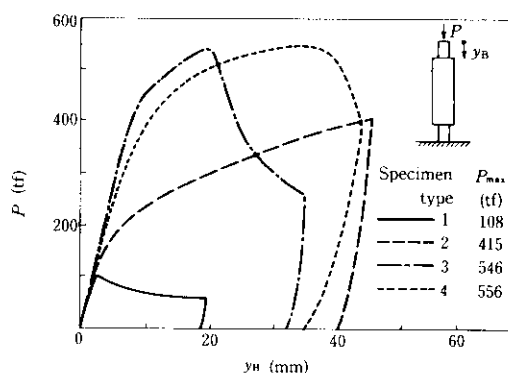
Fig. 11 Load (P)—displacement at the top (y_B) in the compression test

The relationship between the load in the compression test and the degree of head displacement is shown in Fig. 11. All the types showed the same trend, until load P rose to nearly 100 tf. Type 1, when compared with the sound type 4 pipe, showed a P_{max} value of about

20%, indicating that the reinforcing effect against axial load was small. On the other hand, type 2 with ribs, when compared with the sound type 4 pipe, had a larger displacement y_B under the same load, and the maximum P_{max} value was about 85% of that for the sound pipe, indicating the effect of axial load resistance by the ribs. From these experimental results, it was confirmed that repair by fitting an external pipe had a sufficient reinforcing effect against bending, and further, that the fitting of ribs had a reinforcing effect on axial force.
